Manhole Inspection Summary

Manhole # S53C__027MH

Insp Date: **6/12/08 10:10 AM**

Location Address: **3227 e fairmount ave**

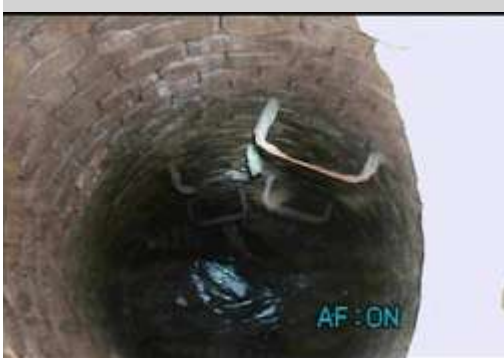
Defect 1

Count: **5** Missing: **1** ☒ **Corroded**

corroded steps

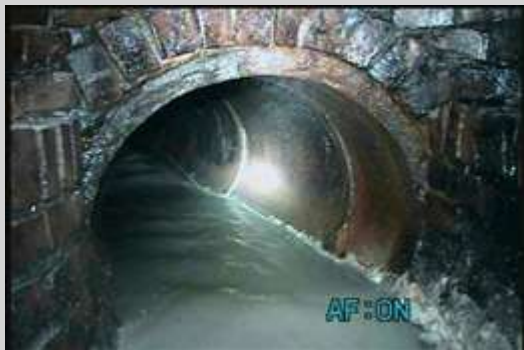
12 O'Clock Outflow

24 in. Circular Gravity Sewer
Pipe Out @ 12 O'Clock

Invert Depth: 12.11 (ft.) Flow Characteristics: **Fast**

Infiltration: **None** Pipe Seal Cond: **Unknown**

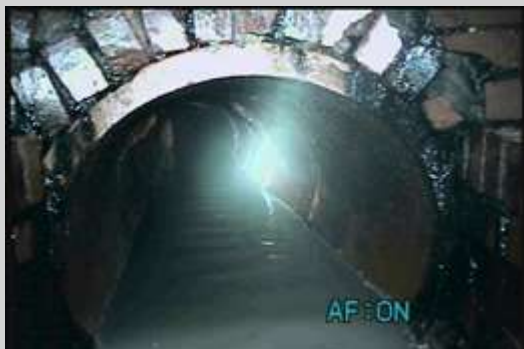
6 O'Clock Inflow

8 in. Circular Gravity Sewer
Pipe In @ 6 O'Clock

Invert Depth: 12.08 (ft.) Flow Characteristics: **Fast**

Infiltration: **None** Pipe Seal Cond: **Unknown**

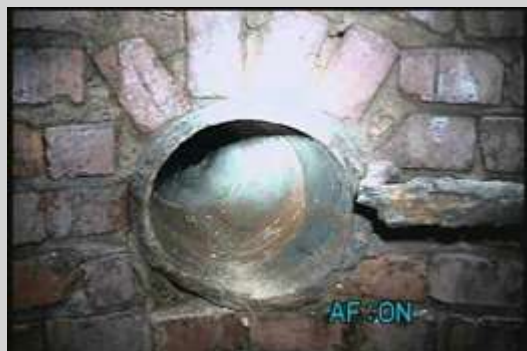
9 O'Clock Inflow

Pipe In @ 9 O'Clock

Invert Depth: **6.64** (ft.) Flow Characteristics: **Fast**

Infiltration: **None** Pipe Seal Cond: **Unknown**

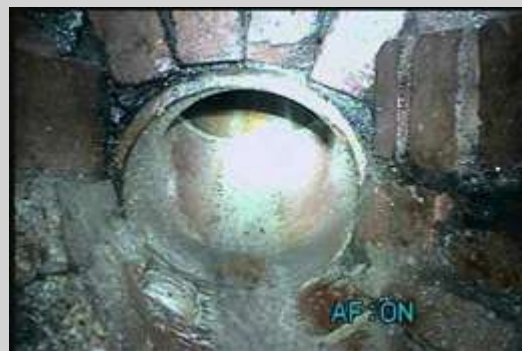
Drop In @ 9 O'Clock

Drop: **Outside** Direct

Inv Depth: **11.50** (ft.)

Drop Condition: **Open**
